# REDUCING FRICTION IN ZAMBONI

ID: 9581

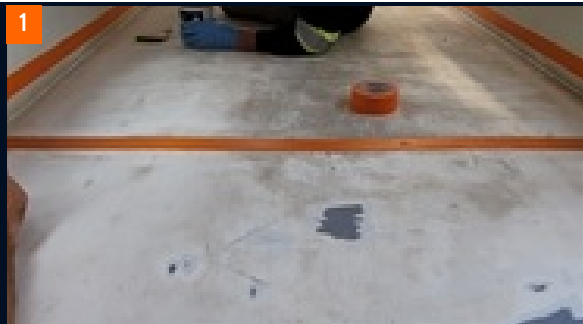
1. Preparing the painted aluminum surface by high grit sanding and removing all loose and overflowing sealant from edges. Taped up the wall a few inches to prevent snow sticking to them as well.
2. Completed surface with Belzona 1341.
3. Completed surface with Belzona 1341.

High friction on the factory coating on the aluminum floor plate inside zamboni snow/ice storage. Makes it very difficult to empty without setting it to maintenance mode and climbing inside.
