# REBUILD SURFACE AND STRUCTURAL STRENGTH OF DIFFUSER PUMP COMPONENT

ID: 9582

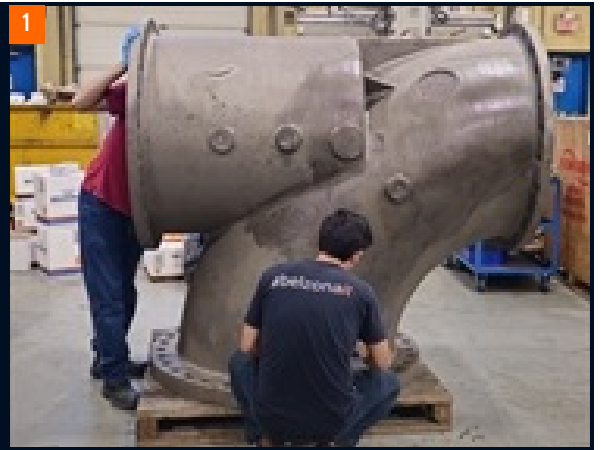
The customer experienced significant erosion issues within the diffuser pump component and, after conducting tests, determined that the structural strength of the part needed to be reinforced.

1. Diffuser Component
2. Belzona 1341 for coating inside the surface
3. Belzona 4141 application to make a uniform shape.
4. Completed work with Belzona Superwrap II
