# BELZONA REPLACES TILE LINING

ID: 9583

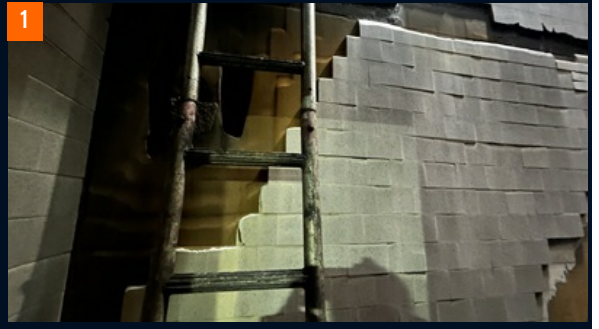
Many damaged tiles and holes on cal reject chutes needed to be repaired.

Massive holes and damaged tile lining was found and required repair in a 48 hour period.

1. As found
2. Holes repaired and ready for tile
3. Tiles and grout completed
