# ZAMBONI BAY CONCRETE RESTORATION

ID: 9584

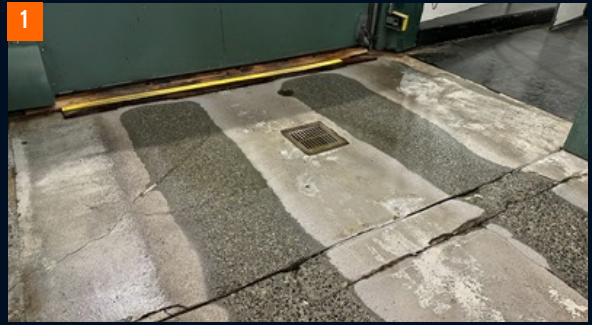
The concrete where the Zamboni exits the ice sheet was badly deteriorated and needed restoration

1. Condition of concrete where the Zamboni exits the ice-sheet
2. Application in progress
3. Completed application, 14 buckets of Belzona 4111 Magma Quartz were used to complete the restoration
4. Completed application

All areas were prepared using Diamond cup grinders. Belzona 4111 Magma Quartz was applied and adequate slopes were maintained to the drains.
