# LOCAL FIREHALL

ID: 9590

## PROBLEM

Rebar was being attacked by moisture and causing it to spall.

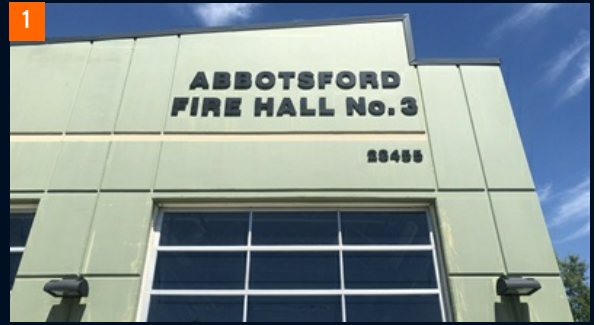
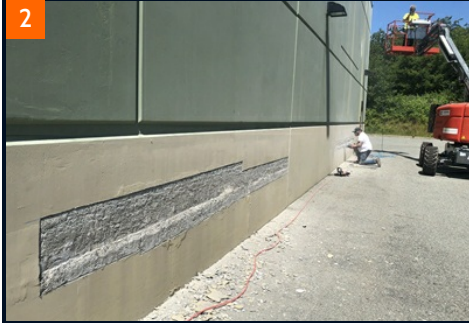
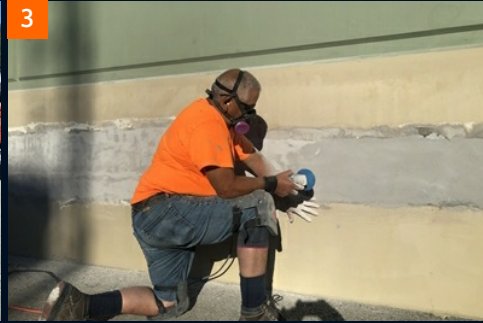
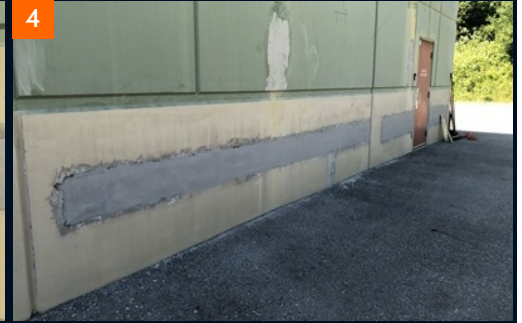
1. Before repainting the firehall the customer needed to make sure that the walls were repaired.
2. All loose areas were removed.
3. After patching the area using Belzona 4111 magma quartz an angle grinder and sanding disc were used to achieve smoothness and a good transition between the old and new coating.
4. Once smoothed out, the area was left for the painting crew to repaint.

Concrete would have taken longer to cure and not offered the same properties as Belzona 4111.

Angle grinder, trowels and sanding discs were used to prep and apply
