# BELZONA REPAIRS EXPANSION JOINT LEAK

ID: 9592

Holes in an acid tank expansion joint needed to be repaired without welding.

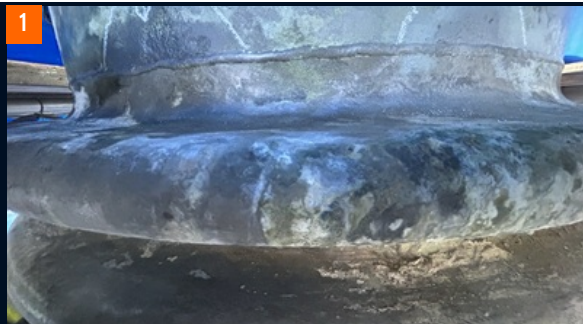
1. Holes found
2. Preparation completed
3. Belzona elastomer and cloth applied
4. The bespoke application crew!
