# PULP MILL'S HOG FUEL RECLAIM WALL REPAIRED AND PROTECTED FOR SMOOTH OPERATION

ID: 9594

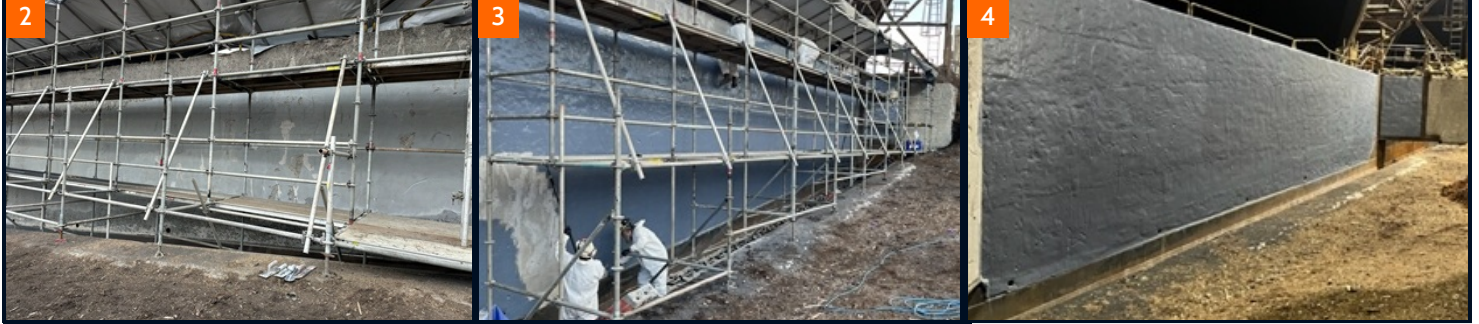
## PHOTOS

The mill load hog fuel for the boiler system. This 15-20 foot wall gets constantly loaded with hog to be sent the boiler via a conveyor system at its base. The wall was badly eroded and 'hang-ups' were occurring and this stopped the flow to the boiler. A slick finish was needed to allow the hog to slide freely to the conveyor below

1. Eroded and damaged wall.
2. Damaged wall.
3. Application of Belzona 4111 to repair concrete.
4. Finished application.

Belzona 4111 was used 2/3 up the wall where the worst wear was present and two coats of Belzona 5821 Immersion Grade AR was applied.
