# FAN COVER PROTECTION

ID: 9596

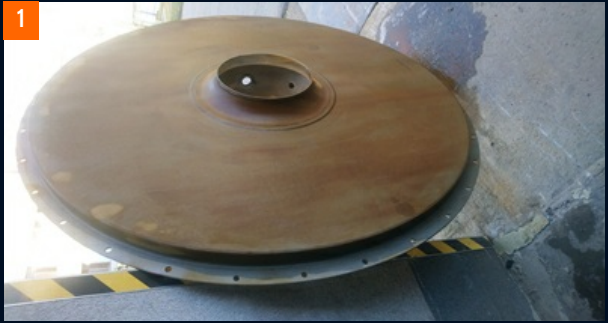
The rubber protection on the fan cover was damaged.

1. Cover after blasting and washing.
2. In terms of cleaning the cover from acids, it was necessary to wash and blast the cover several times.
3. Temperature control during coating curing in the oven.
4. After applying Belzona 1392.

Removal of old damaged rubber coating. Blasting the inner surface of the cover according to the Sa2.5 standard to a minimum profile of 75 microns. Multiple degreasing, cleaning, blasting. Application of protective coating system Belzona 1392. Curing of the material in the oven at a temperature of 50°C.
