# REPAIR OF THE DUMP BODY.

ID: 9598

## PROBLEM

Strong abrasion caused damage to the surface of the dump.

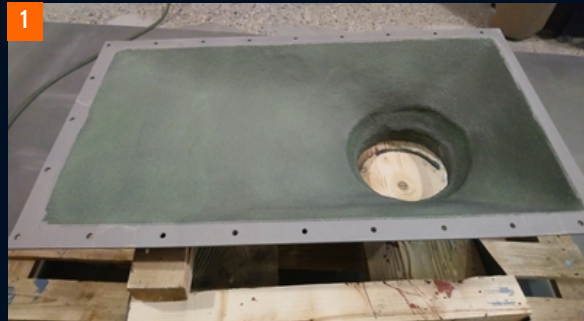
Strong abrasion of products for the production of building materials caused damage (loss of material) to the dump. This caused production outages and equipment breakdowns.

1. The missing original material was filled with the Belzona 1813 product.
2. Belzona 2111 product application.
3. Belzona 1813 was applied at a thickness of 5 mm.
4. Belzona 2111 was applied at a thickness of 3 mm.

Surface blasting to the required Sa2.5 standard. Degreasing. Application of Belzona 1813 to the cleaned surface of the device in a total thickness of 5 mm to level the unevenness of the internal surface. Blasting and roughening of the surface. Belzona 2911 conditioner application + Belzona 2111 application.
