# REPAIR OF THE DAMAGED WALL AND BOTTOM OF THE BOILER CONDENSATION CONTAINER

ID: 9600

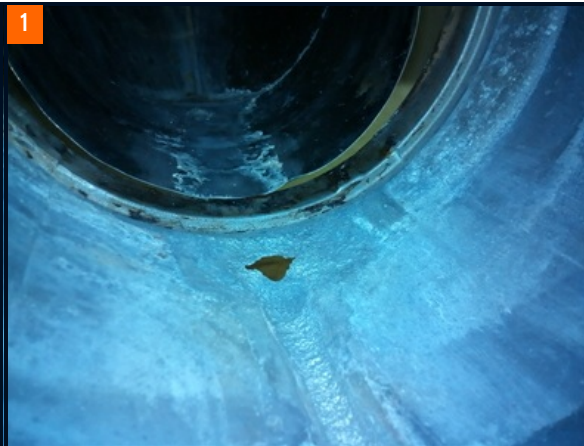
When using the Buderus condensing boiler, the bottom and walls of the boiler were damaged by corrosion.

Corrosion caused damage to the bottom and walls of the boiler, making further use impossible.
