# ANTI-CORROSIVE PROTECTION OF THE GUTTER ON THE WATER TREATMENT PLANT.

ID: 9601

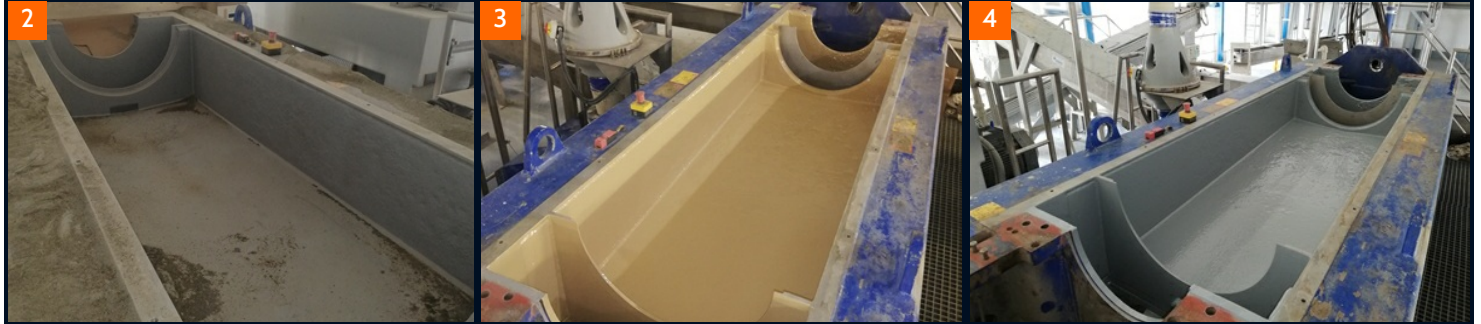
Corrosive damage to the gutter occurs during water purification at the wastewater treatment plant.

Corrosion of the gutter surface caused damage to the walls, but also polluted the water itself. It was necessary to stop it and ensure that it does not appear again in the near future.

1. Corrosive damage to the gutter.
2. Before applying Belzona products, it was necessary to blast the gutter.
3. Application of the first layer of Belzona 5811.
4. Application of the second layer of Belzona 5811.

Blasting the surface to the required standard Sa 2.5. Application of protective coating Belzona 5811 in two layers.
