# BELZONA USED FOR THE REPAIR AND PROTECTION OF THE DISTRIBUTOR HEAD OF THE EXCHANGER

ID: 9603

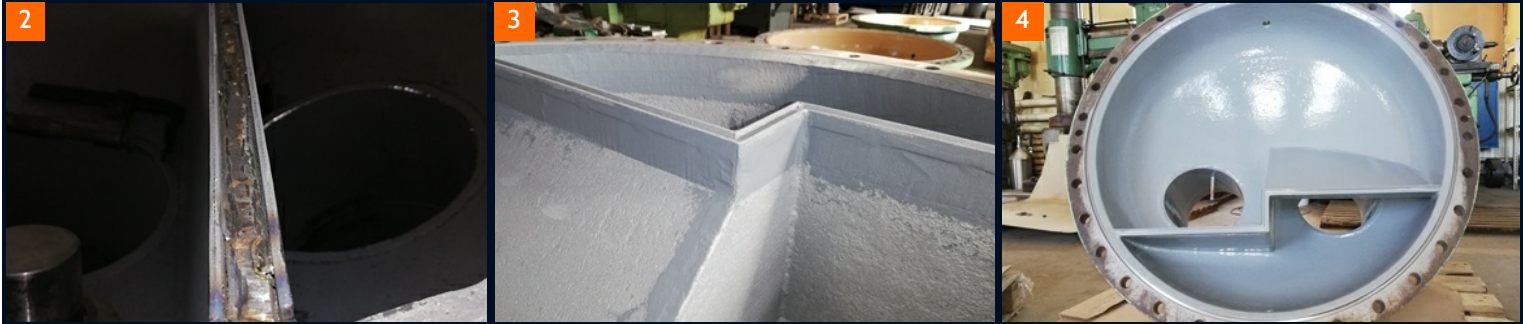
Damage to the distribution head of the exchanger causes poor distribution of hot water and a decrease in the efficiency of the exchanger.

The hot medium and constant circulation caused damage to the dividers of the exchanger, which significantly reduced its performance. The customer was looking for a way to solve this problem.

1. Damage to the distributor head of the exchanger.
2. It was necessary to create new partitions.
3. Replacement of the lost original material with the product Belzona 1511 (Super HT-Metal).
4. Belzona 1391T product application.

Surface blasting to Sa 2.5 with a profile of 75 µm. Surface degreasing. Repair of the partitions of the distribution head by welding new steel bars. Application of Belzona 1511 (Super HT-Metal) on the most damaged parts. Hardening of the material - frostblasting. Application of Belzona 1391T in two layers with a total thickness of approx. 900 µm
