# BELZONA 1212 AND BELZONA 9621 STOP THE PULP WATER LEAK.

ID: 9604

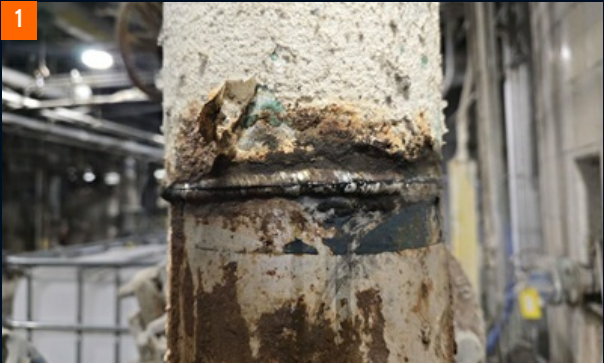
The stainless steel pipe seam had a defective weld allowing the pulp processing water to leak from the joint and had been for many years.

- 1. Original Condition.
- 2. Removing the rust and pulp fiber and roughening the surface.
- 3. Belzona 1212, 9341, and 9621 in place.
- 4. Final layer of Belzona 1212 applied.
