# BELZONA RESTORED AND PROTECTED THE OIL SEALING SURFACE OF WIND TURBINE

ID: 9607

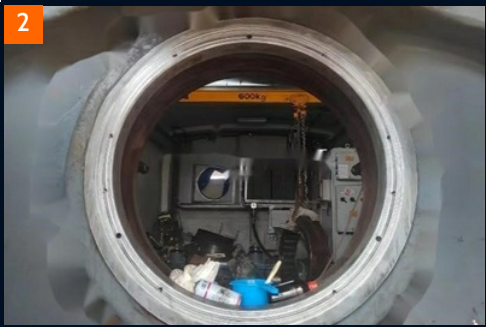
The oil sealing surface of a wind turbine at the wind farm were worn out and needed to be repaired.

The operating temperature was ambient. Wind farms were very windy and the sealing surface of the wind turbine was heavily abraded.

- 1. Full view of wind turbine
- 2. Sealing face before repair
- 3. During application
- 4. Application finished

The application was carried out in accordance with Belzona Know-How leaflets FBC-05. Surface preparation was carried out by grinding with an angle grinder, followed by repair and protection of the sealing surfaces with Belzona 1311.

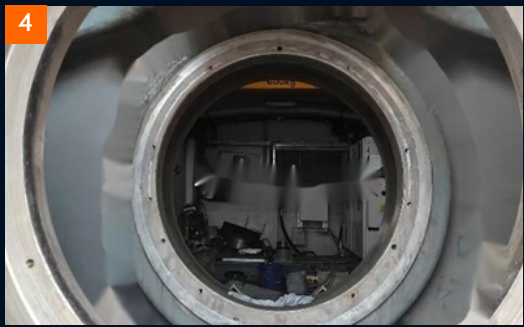
After four months of use, no leaks were seen in the inspection and the client was very satisfied with the results. This solution greatly reduced the cost of replacement for the client, as well as downtime.
