# PROTECTION OF THE BOTTOM OF THE TANK AGAINST CORROSION

ID: 9608

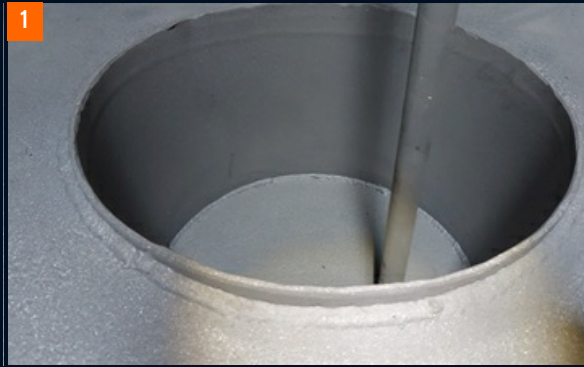
Damage appeared on the bottom of the tank due to corrosion.

1. Detail of blasting.
2. Blasted tank bottom.
3. Application of the product Belzona 1391 T in two layers.
4. General view of the tank

Surface blasting to Sa 2.5 with a profile of 75 µm. Surface degreasing. Application of the product Belzona 1391 T in two layers with a total thickness of approx. 900 µm. Curing of material
