# REPAIR OF WELDS IN STAINLESS STEEL GUTTER.

ID: 9609

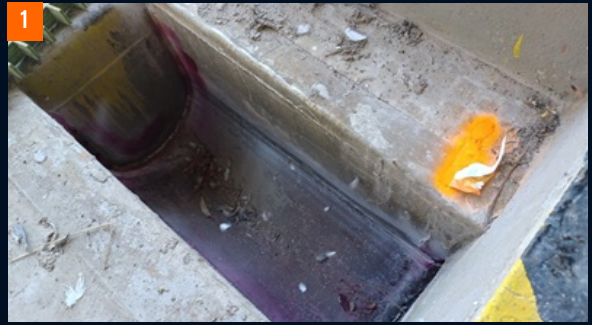
The welds started to crack in the stainless steel gutter.

1. Damages in the gutter were detected with a test spray.
2. Cracks on the bottom of the gutter.
3. Replacement of original material with Belzona 1511 product.
4. Wrap and reinforce with Belzona 1983 SuperWrap II + 9381 products.
