# TURBINE IMPELLER PROTECTED USING BELZONA.

ID: 9610

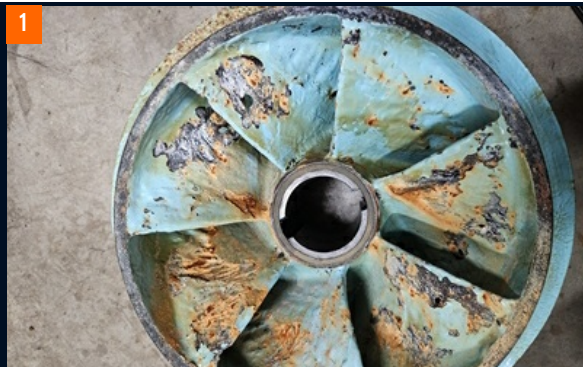
The turbine was damaged by the erosion-corrosion process.

The impeller was painted about 5 years ago with a material from a competing company, which was damaged. The customer applied the material himself. Now he was looking for a better solution.

1. Damaged paint from a competing paint manufacturer.
2. Filling damaged blades with Belzona 1311 (Ceramic R-Metal).
3. Application of Belzona 2141 (ACR-Fluid Elastomer)
