# ELECTRIC MOTOR SHAFT REPAIR

ID: 9616

## PROBLEM

Damaged shaft under the bearing.

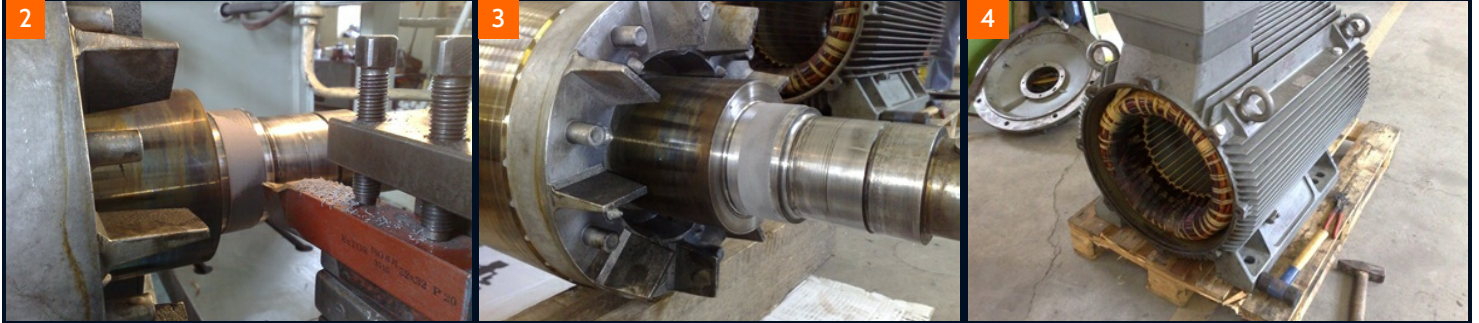
## PHOTOS

Due to long-term use of the electric motor, the shaft was damaged. The customer was looking for a quick and high-quality solution. Our company has very good results with such repairs.

1. Damaged shaft under the bearing.
2. Processing of Belzona 1111 product
3. Repaired shaft
4. The shaft belongs to an electric motor with a power of 315 kW, manufacturer MEZ

Machining the shaft to the required profile. Application of the product Belzona 1111. Curing. Processing the product Belzona 1111 to the required size.

This type of repair (using the Belzona 1111 product) is one of the fast and high-quality solutions. Also, there is no thermal influence, as happened with welding.
