# BELZONA COLD PLATE BONDS IN FLOUR SILO

ID: 9617

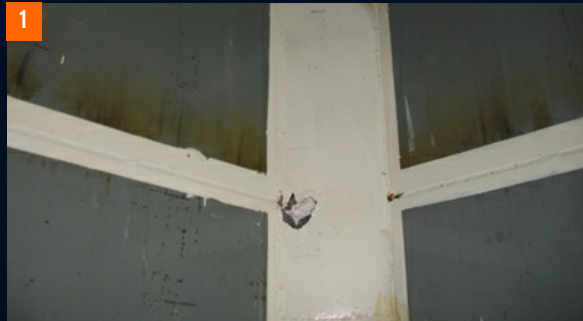
Corrosion in flour silos had lead to through wall defects

1. Corroded area
2. Preparation with MBX
3. Plates bonded
4. Overcoated with Belzona 1341
