# REPAIR OF THE PINION SHAFT

ID: 9618

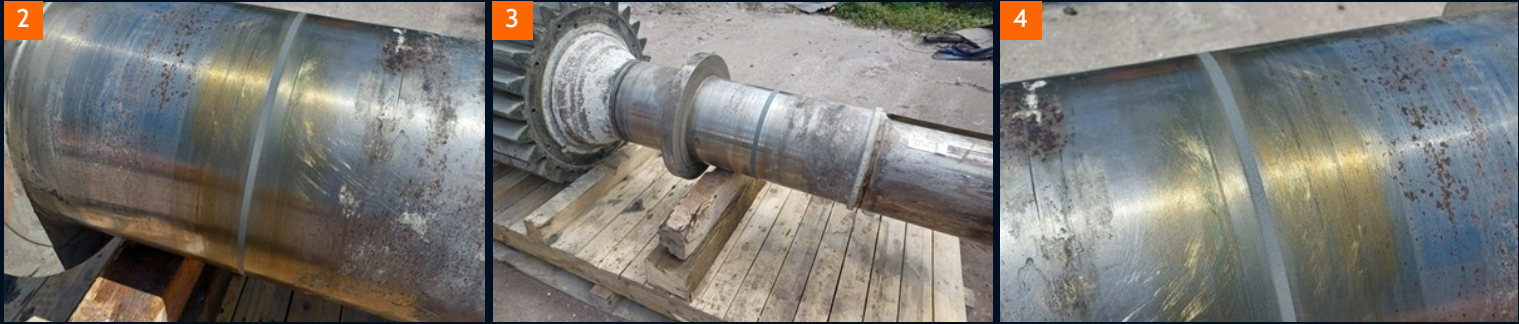
**PHOTOS**

**PROBLEM**  
Damaged shaft under the bearing.

**APPLICATION SITUATION**  
Due to long-term use of the machine, the shaft was damaged. The customer was looking for a quick and high-quality solution. Our company has very good results with such repairs.

1. Damaged shaft under the bearing.
2. Repair detail
3. Shaft after repair
4. Belzona 1111 was used for the repair

**APPLICATION METHOD**  
Surface blasting according to the required Sa2.5 standard. Degreasing. Application of Belzona 1111 material. Curing. Processing to the required size.

**BELZONA FACTS**  
Damage to the shaft under the bearing prevented the functionality of the pinion shaft. The repair using the product Belzona 1111 was quick and of high quality.
