# BELZONA REBUILDS SEA WATER FILTER FLANGES

Severe crevice corrosion and galvanic cavities on the flanges.

6 x Seawater Filter Baskets

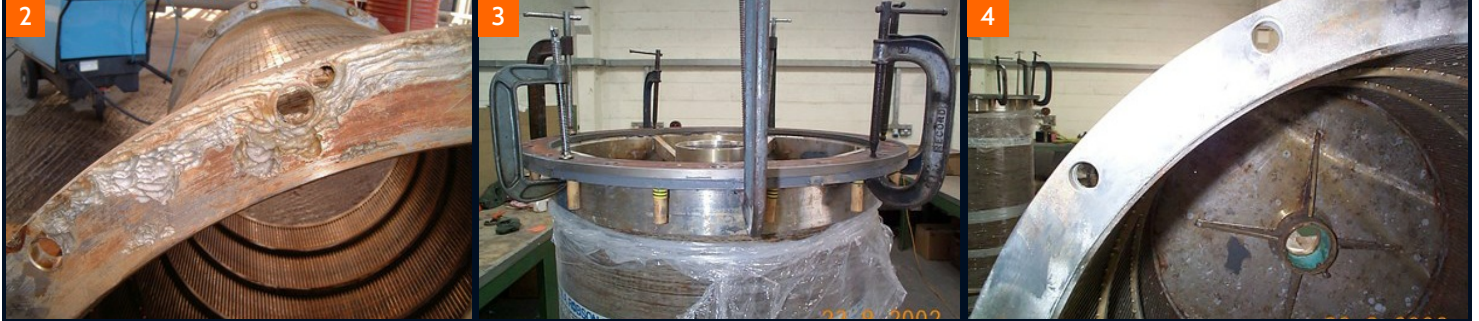
## PHOTOS

1. A section of a seawater filter basket
2. Severe crevice corrosion on 18 flanges
3. Belzona 1111 in place and curing
4. Final result

A former was manufactured and with the use of spacers, clamps and release agent, the Belzona® 1111 was formed into perfect flange faces.

Time did not allow for replacement baskets to be manufactured. Belzona was the obvious answer to the rebuilding of the corroded areas and the prevention of further bi-metallic corrosion. Inspected in 2007 flanges still performing OK allowing equipment to be re-assembled with no remedial work required.
