# 7 PUMPS FOR BELZONA

ID: 9621

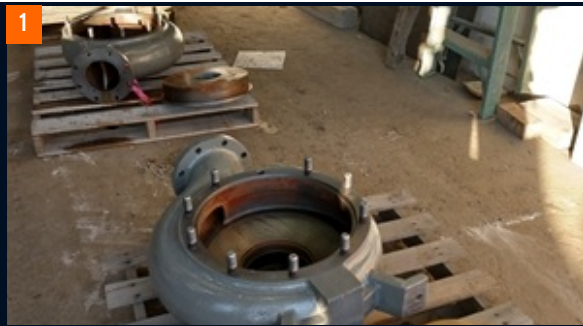
1. Brand new pumps ready to be coated.
2. First coat of Belzona 1341 applied.
3. Applying the second coat of Belzona 1341.
4. All 7 pumps completed.

The pumps and parts were grit blasted to a 5 mil profile, washed with solvent. Belzona 1341 was applied by brush.
