# PUMP PLINTH REBUILD

ID: 9622

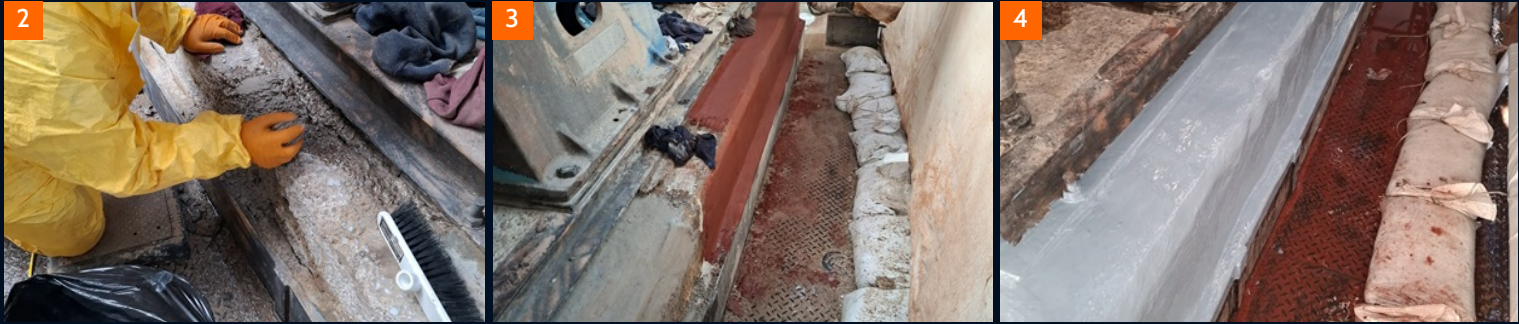
Over time the plinth surface had deteriorated due to constant contact with hot caustic.

Plinth had deteriorated due to constant contact with hot caustic.

- 1. Initial condition of plinth
- 2. Application of Belzona 4131
- 3. Application of Belzona 4181
- 4. Overcoated with 1391T

Area cleaned with high pressure water to remove caustic residue.  
4911 used as surface conditioner before application of 4131 which was used to rebuild profile of plinths.  
4981 used as a conditioner before application of 4181 which will give resistance to caustic at elevated temperatures.
