# ROLL CRUSHER ABRASIVE LINING

ID: 9625

## PROBLEM

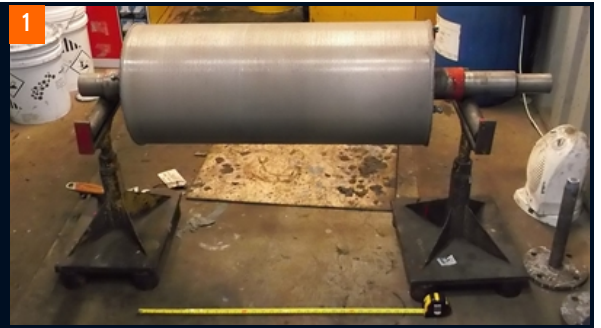
Roll crushers in use in a sludge processing plant were experiencing excessive wear in service.

1. Crusher before surface preparation
2. Surface prepared & wet out with Belzona 1812
3. 5mm lining of Belzona 1812 applied
4. Roll crushers machined & put into service. Image taken 18 months, minor damage noted.

A profile was machined into the surface of the crushers. Scrubbing brushes were used to wet out the surface. 5mm of Belzona 1812 was then built up. The surface was then machined down flat on a large lathe with PCD cutting tools.

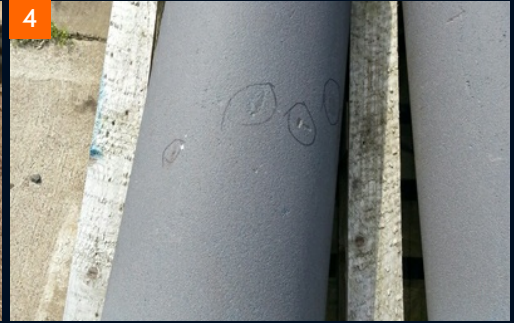
These crushers go into service for around 18 months before being taken out. Minor repairs from contact with hard objects is noted & can typically be spot repaired.
