# TANK REPAIR AND PROTECTION

ID: 9626

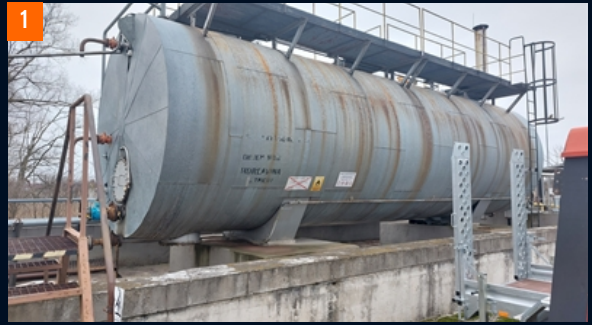
1. General view of the tank
2. Damaged tank bottom
3. Fixed tank bottom
4. Ready for operation

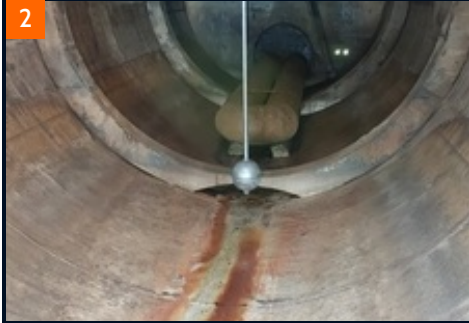
Corrosion damaged the bottom of the tank and there was a danger that the bottom of the tank would break through.

After a long time and due to aggressive chemicals from crude oil, the bottom of the tank was damaged. There was even a hole in the tank.

Surface blasting to Sa 2.5 with a profile of 75 µm up to the height of 1/3 of the shell.

Surface degreasing. Bonding of a metal plate to the bottom of the tank under the heating body (leakage at the bottom of the tank) with Belzona 1111.

Application of the product Belzona 5892 in a thickness of approx. 500 µm. Hardening of the material - by additional heating.
