# BELZONA SOLUTION FOR PULSATION DAMPENERS REPAIR

ID: 9627

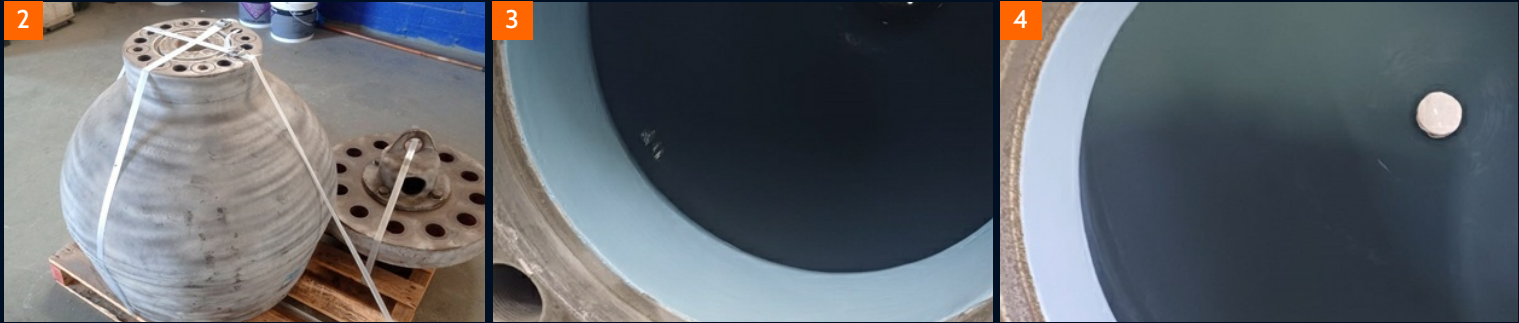
The dampeners previously suffered from severe corrosion and erosion, often leading to costly repairs and frequent replacements. However, after the application of the Belzona repair and coating system, these issues have been effectively resolved. The dampeners now remain in operation for longer periods and are frequently returned for re-coating due to the proven reliability of the solution.

- 1. Picture of the dampener before coating
- 2. Dampeners
- 3. After coating with Belzona
- 4. After coating with Belzona

The dampener is abrasive blasted to achieve a minimum surface profile of 75 microns and a near-white metal finish in accordance with SA 2.5 standards. Following surface preparation, the repair and coating solution is applied using a short-bristle brush, as per the Instructions for Use (IFU).
