# REPEATED COATING OF SPLIT CASING PUMP FOR DRINKING WATER

ID: 9629

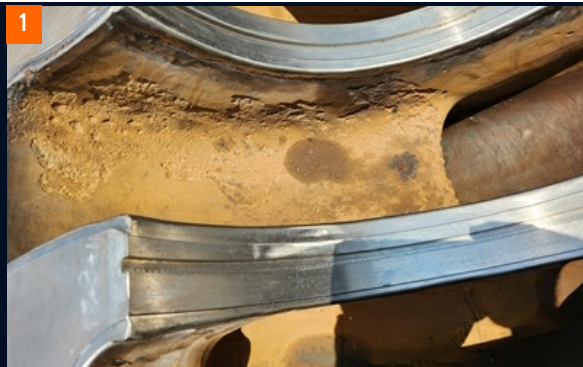
The pump owner was faced with the problem of erosion-corrosion inside the pump, causing pitted areas in the internal surface every two years. To solve this problem, Belzona's pump solution with rebuilding and coating was used.

1. Pitting damage on the pump casing
2. Pump casing before application
3. Pump casing protected with Belzona pump coating

For the surface preparation, the pump was blasted to achieve a minimum profile of 75 microns and Near White Metal. Pitting and damages were rebuilt using Belzona 1111, and then 2-coat system of Belzona 1341N was applied in accordance with the Instruction For Use.
