# BELZONA REPAIRS AND PROTECTS SULPHURIC ACID BUND

ID: 963

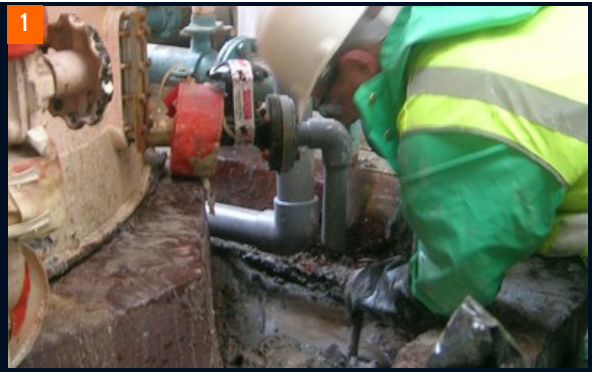
Malfunction in the system caused a quantity of 98% Acid to be dropped, followed by a quantity of distilled water. The resultant exothermic reaction was so rapid it stripped the original coating off the concrete substrate throughout the containment area.

1. Damaged tank pad
2. Rebuilding with Belzona 4111
3. Rebuilding complete
4. Tank pad protected with Belzona 4311
