# BELZONA PROTECT SPENT CAUSTIC REACTOR

ID: 9631

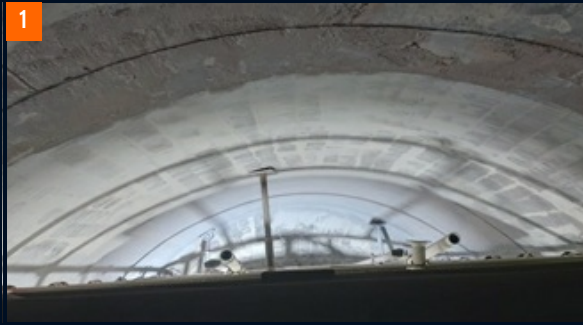
The customer relied on the reactor to treat spent caustic, but the old lining system had failed, causing frequent shutdowns that resulted in losses of \$20,000 per day. To address this issue, we recommended Belzona 1593 as a durable and effective solution.

1. Internal reactor body before coating
2. Close-up of the reactor manhole showing damage and corrosion of spent caustic over metal.
3. Belzona 1511 is applied
4. Final phase with Belzona 1593

The old coating was removed, and the surface was prepared through blasting to achieve a minimum profile of 75 µm and a near-white metal finish. Belzona 1511 was applied to smooth out welding joints, while Belzona 1593 was used to coat and protect the entire reactor.
