# REFURBISHMENT OF ENERGY FROM WASTE PROCESS PLANT

ID: 9634

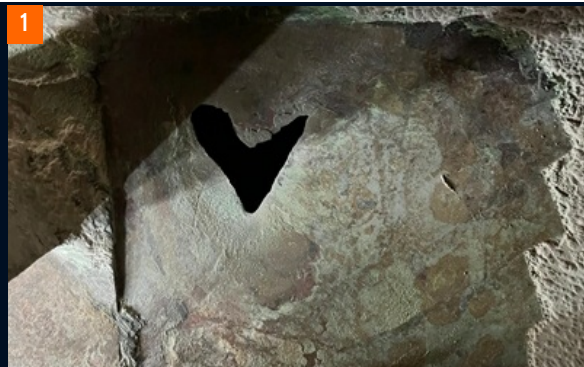
Customer was suffering severe internal corrosion within their process plants pillenium & re-circulation channels. This was due to high concentrations of Calcium Oxide (37%) and Chlorine (26%) operating at temperatures of 140 Deg. C.

1. Internal through hole defect.
2. Holed & corroded section of internal system.
3. Plate bonding and coating of localised defects.
4. Plate bonding and coating of localised defect.

The preparation was carried out by grit blasting to Belzona's IFU Specification sheets for the products. Where required, plates were bonded into place on through hole defects where required using a Belzona paste grade. Belzona 1593 was then applied to the repaired areas.
