# LEAKING WATER LINE REPAIRED WITH BELZONA 1161 AND 1212

ID: 9637

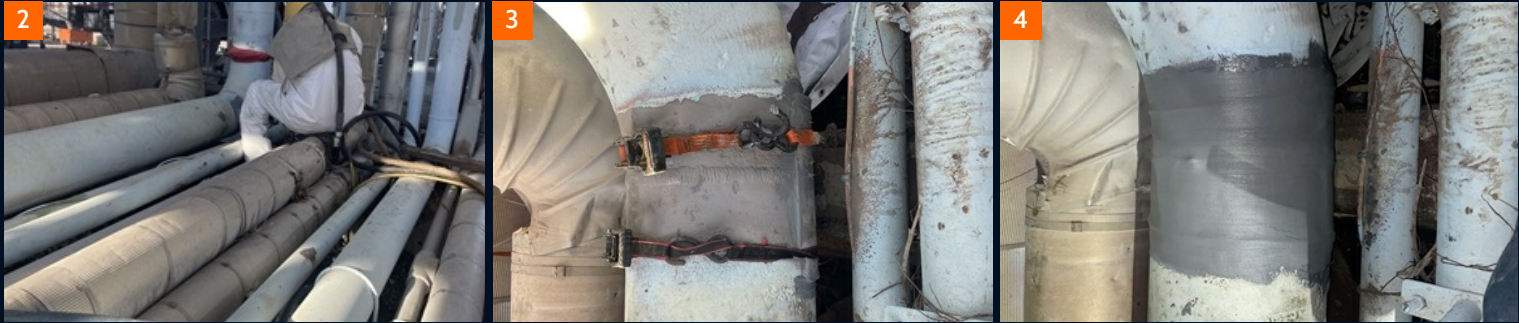
Customer had a significant leak on a 12" supply water line. The water line was corroded at the pipe support base, with multiple hole through locations.

- 1. Corroded pipeline.
- 2. Application of Belzona 1161.
- 3. Application of cold bonded plate with Belzona 1161.
- 4. Finished application with Belzona 1212.

Customer Called late afternoon on a Friday with this pipe leak, Belzona was able to mobilize and be on site within an hour. the application crew was able to plate bond over the multiple holes in pipe and then we wrap over the plate to secure plate and stop any future leaks. Customer was able to fill line back up in a matter of a few hours saving them days of down time and also saving money

Cold plate bond using Belzona 1212, then wrapping with Belzona 9341 Reinforcement Sheet with Belzona 1161
