# SEA WATER VALVE REFURBISHMENT

ID: 9638

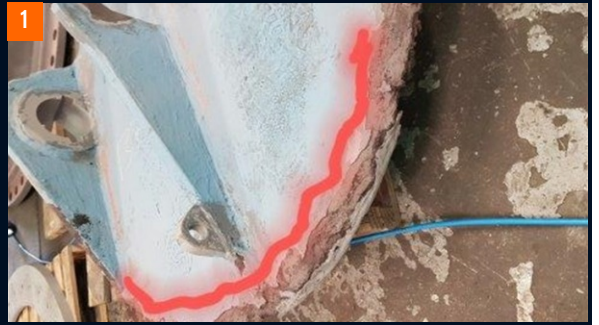
Valve was heavily corroded and worn out due to the saltwater attack.

1. Worn out metal
2. Welding metal supports before applying Belzona 1111 (Super Metal)
3. Belzona 1111 (Super Metal) rebuilt the damaged metal surface
4. Valve coated with Belzona 1341 (Supermetalglide)

1. Rebuild the worn metal with Belzona 1111 (Super Metal)
2. Machine to the original dimensions to get a proper seal area
3. Overcoat the part with Belzona 1341 (Supermetalglide)
