# BELZONA PROVIDES INTERNAL PUMP REFURBISHMENT WITH CERAMIC COATING SYSTEM

ID: 9639

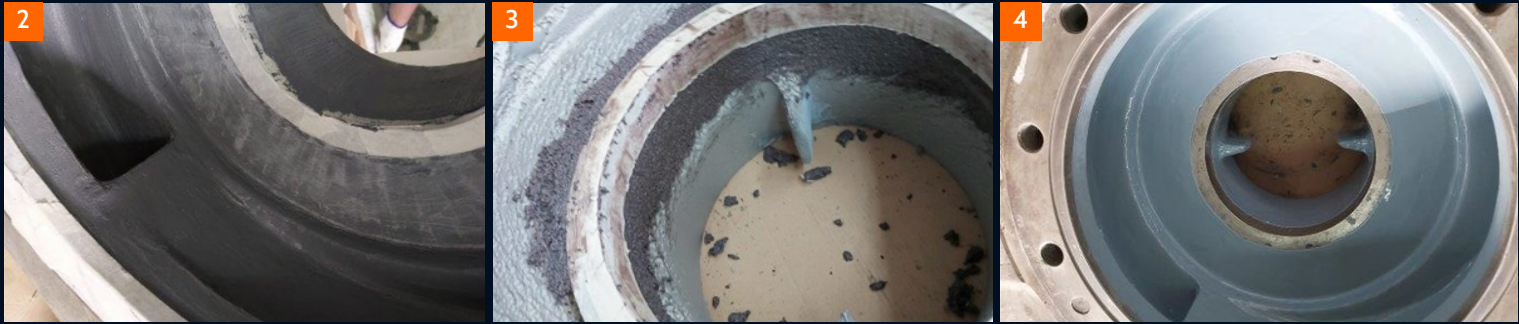
The pump suffered severe erosion caused by high solid content in the fluid

The pump experienced severe erosion and extensive wear, resulting in a significant loss of efficiency.

- 1. Erosion evidence on pump component due to high solid content
- 2. Surface preparation on the pump before the application of Belzona system
- 3. Pump surface was rebuilt with Belzona 1311 (Ceramic R-Metal)
- 4. Once the surface was rebuilt, Belzona 1321 (Ceramic S-Metal) was applied to enhance protection and prevent further damage.

- 1. Apply Belzona 1311 to rebuild the worn-out metal
- 2. Overcoat the rebuilt pump with Belzona 1321 (Ceramic S-Metal)
