# BELZONA SMOOTHS OUT DAIRY RAMP

ID: 964

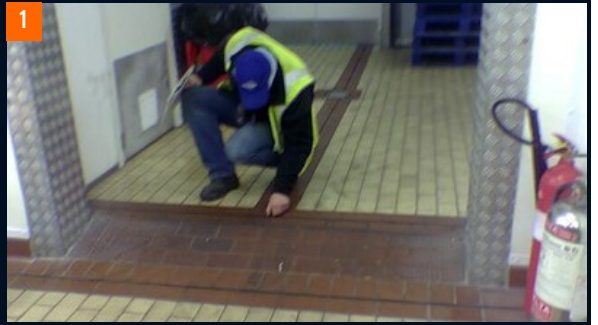
The slope was causing product being transferred from section to section by electric hand truck to be both unstable on the pallets and a safety hazard when travelling down the slope.

The factory has grown over a number of years with each new section at different floor levels. The area in question had a very short steep ramp between the creamery and the store area.

1. Inspection of ramp prior to work
2. Application of Conditioner prior to Belzona 4111
3. Application of Belzona 4111 begins
4. The finished ramp

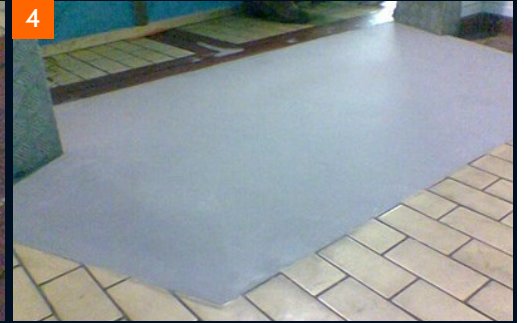
The Factory works non-stop and the safety issue could not wait for a shutdown. The window to work in was very short, 36 hours maximum. Client chose Belzona on grounds of technical support ensuring application completed in tight time frame. The ramp looks as good as new more than 12 months later.
