# PIPE GIRTH WELD INTERNAL COATING

ID: 9640

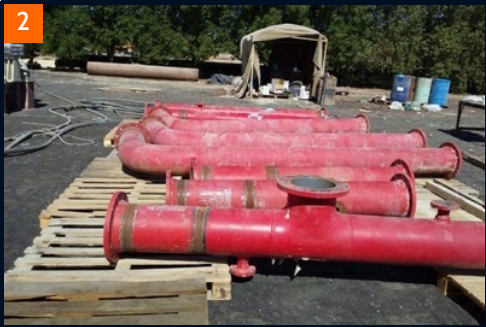
Pipes are coated with Fusion Bonded Epoxy Coating (FBE) from manufacture but after welding, the fitting FBE coating got burned and needed repair.

- 1. Damaged pipe girth
- 2. Damaged pipe girth needed repair
- 3. Measuring the surface roughness before starting Belzona application
- 4. Spark testing in progress to detect pinholes for a flawless protective coating.

- 1. Do grit blasting to remove the burned coating until the required profile and cleanliness is achieved.
- 2. Apply Belzona 1391T onto the internal fitting.
- 3. Spark testing to detect if there are any pinholes.
