# PUMP HOUSING REPAIR AND COAT

ID: 9641

Customer had issues with pump housing getting severely eroded in service.

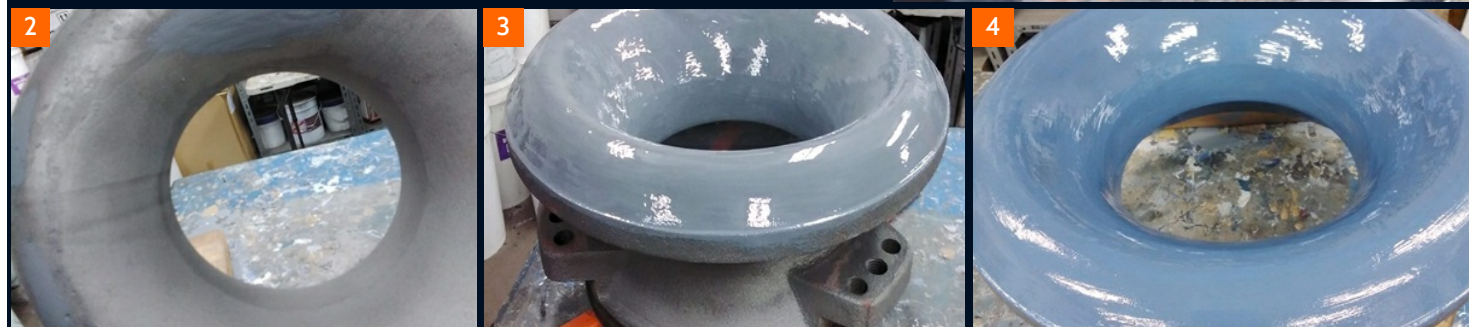
1. Damaged pump housing.
2. Pump housing abrasive blasted and Belzona paste grade metal utilised to repair erosion.
3. First coat of Belzona 1321 applied.
4. Pump housing complete with final coat of Belzona 1321.

Pump housing was abrasive blasted to a S.A 2.5 standard (75 micron) profile before all eroded sections been rebuilt with Belzona 1311 paste grade metal. There after 2 coats of Belzona 1321 was applied for long term protection against erosion.
