# LINING OF A YACHT'S DIESEL TANKS

ID: 9645

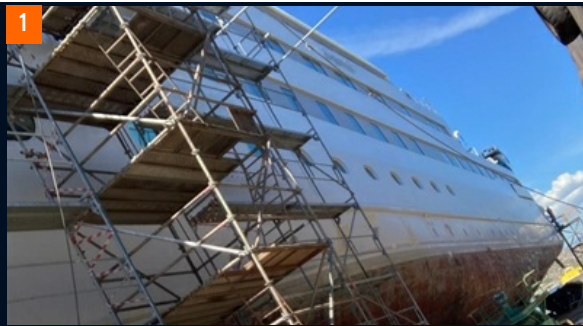
1. Yacht external view at the shipyard
2. Application of Belzona 1311 to rebuild pitted areas
3. Application of Belzona 1321 on top of Belzona 1311
4. Finished job

Before 1311 was applied to the substrate after it was grit blasted. The lining material was Belzona 1321.
