# COLD BONDING PIPE SUPPORT BRACKETS TO TANK

ID: 9648

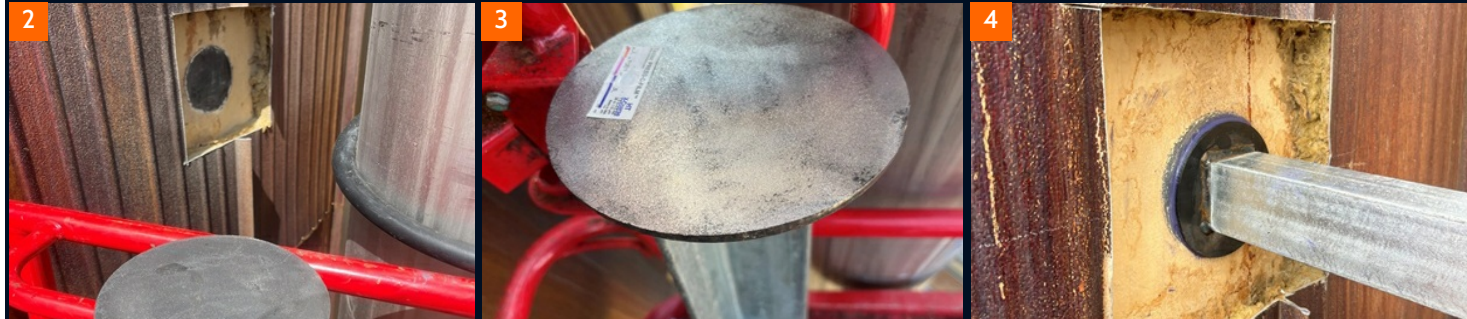
## PHOTOS

1. Client identified and marked where support to be bonded on tank exterior.
2. Pipe support and bond area perspiration.
3. Pipe support bond pad surface profile readings were taken prior to bonding.
4. Pipe support bonded to prepared tank substrate Belzona 7311.

Application was carried out with all surface preparation executed with TFT Pneumatic Rough Boy sparkless profiling tool. Therefore, eliminating any hot work in areas and potential damage to internal liner of vessel.
