# PLATE HEAT EXCHANGER

ID: 9649

Corrosion due to salt water environment on end plates of plate heat exchangers.

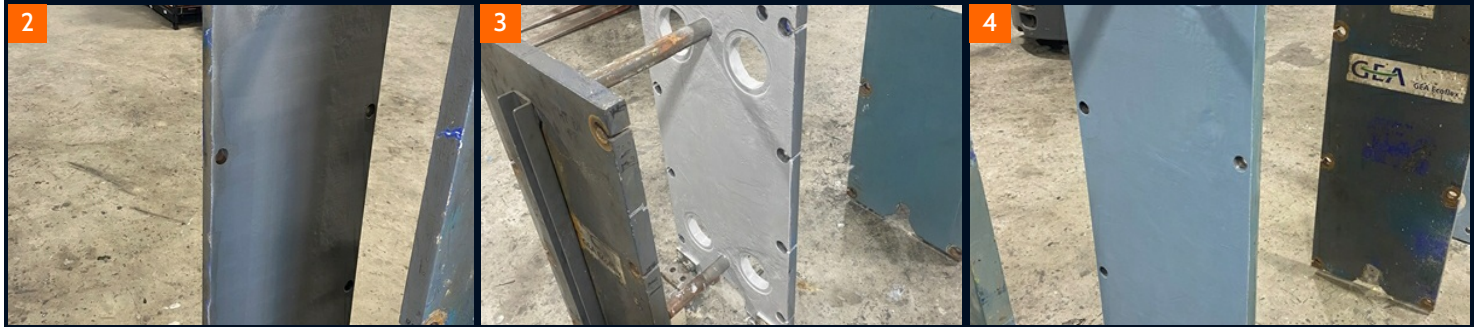
1. Areas to be rebuilt/coated were checked for chlorides, chlorides were neutralized to acceptable levels, units were blasted and profile checked as per product manufactures recommendations.
2. Application of 1511 to fill in pitted and corroded areas prior to coating.
3. Application of first coat of 1593
4. Application of 2nd coat 1593

Repair areas were abrasive blasted, and chlorides were checked and neutralized to acceptable levels prior application of Belzona 1511/1593 System
