# BELZONA PROTECTS ENGINE SUMPS AT OEM

ID: 965

Fabricated Steel Sump

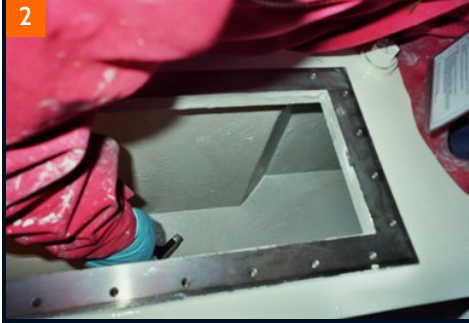
1. Coating the difficult areas
2. Inspection by mirror
3. Good clean surface finish
4. An indication of the access difficulties encountered
