# BELZONA 1814 SCREW CONVEYOR PROTECTION

ID: 9652

Screw conveyor used to skim sludge from the base of a silo at a biomass plant.

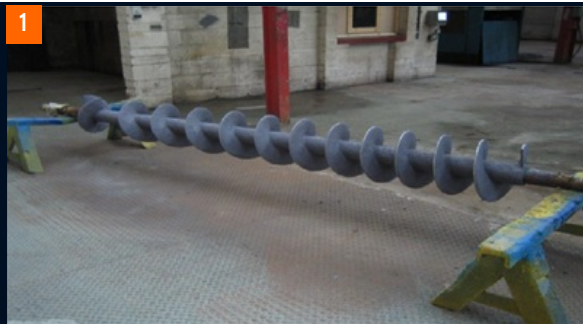
High abrasion was leading to unprotected screws only lasting 3-4 months in service. Previous Belzona applications on this type of screw was completed with Belzona 1812, which extended their life to over 2 years.

1. Initial condition
2. After Belzona 1814
3. After Belzona 1814
