# BELZONA SAVES CUSTOMERS NEW STEEL CHUTES AND HOPPERS FROM ABRASION ATTACK

ID: 9654

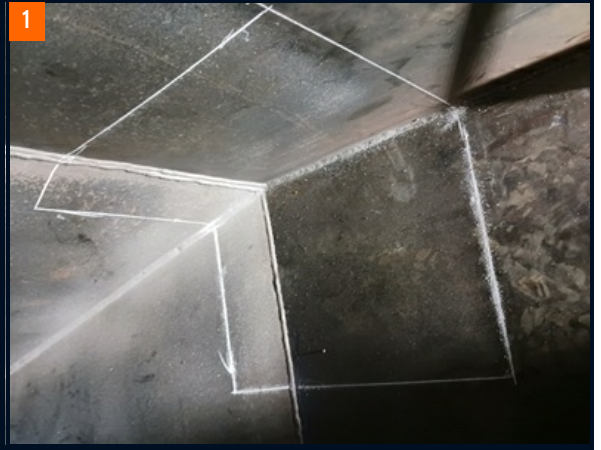
1. Area laid out for the application of Belzona 1812
2. Shop Crew working on Preparation of chute and hopper
3. Belzona 1812 applied to the first area
4. Belzona 1812 applied to both areas on the first chute and hopper

The new chutes and hoppers had been blasted to an SSPC-SP10 near white finish c/w a 3mil depth profile, cleaned by using a vacuum, than degreased with Belzona 9111, and than Belzona 1812 was applied to the prepared surface at a thickness of 0.12"
