# BELZONA COATING FOR MILL SCALE WASTEWATER CHANNEL IN STEEL INDUSTRY

ID: 9656

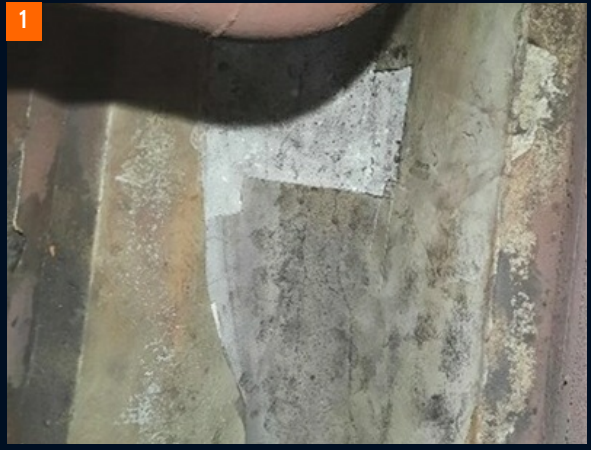
The competitor's repair was failing mainly between the concrete and the primer, but some delamination also occurred between the middle and top layer.

1. Damaged substrate
2. Application in progress
3. Application in progress
4. Finished application

First the failing competitor coating had to be removed.

To prepare the substrate for the Belzona solution, the concrete substrate was grit blasted.
