# TEST SEPERATOR INTERNAL COATING

ID: 9657

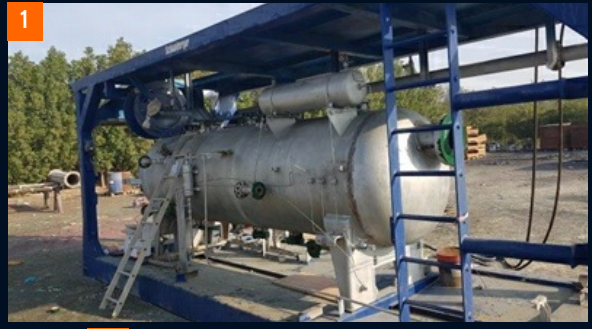
Test separator internal surfaces were heavily corroded due to the corrosive operating media, including cured oil, water, and mud.

Test separator was heavily corroded and pitted due to the corrosive media and elevated temperatures during operation.

1. The test separator's internal surfaces suffered severe corrosion.
2. Internal surfaces were heavily corroded due to aggressive media.
3. Evidence of severe corrosion damage on test separator internal surfaces
4. Complete application of Belzona solution on test separator internal surfaces

1. Rebuild the worn metal with Belzona 1511
2. Topcoat the internal substrate with Belzona 1593 to fully protect the surface from further attacks.
