# BELZONA 1111 FOR FLANGE FACE REPAIR

ID: 9659

Worn-out flange face needs to be repaired

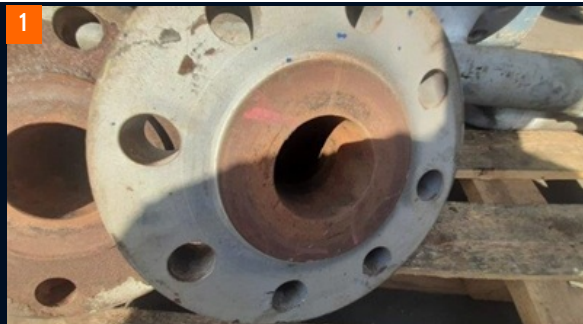
1. Worn-out flange face need repair
2. Forming technique was used to rebuild the flange face
3. Flange face was successfully restored and ready for service
