# BELZONA DRAIN COVERS

ID: 966

Deterioration of drain covers and surrounds

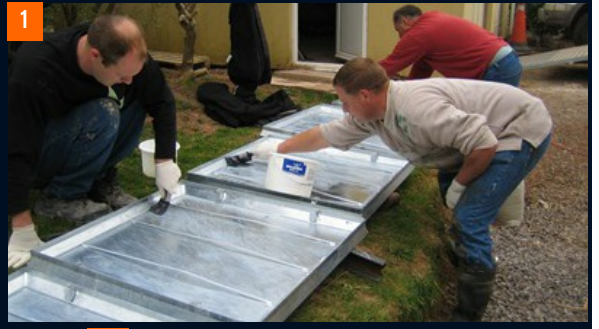
1. Fabricated drain covers in Steel being conditioned
2. Bulk out Belzona 4111 being applied
3. Bulk out Belzona 4111 finished ready to be topped off with Belzona 4111
4. Finished cover ready for transport and installation on site

Application was carried out in accordance with a modified Belzona Know-How System Leaflet FPA-1. New drain covers were manufactured off-site from Stainless Steel and infilled with Belzona® 4111. On site bedded into Belzona® 4111 and damaged surrounds rebuilt.
