# COOLING WATER HEAD BROUGHT BACK TO LIFE WITH BELZONA 1391T

ID: 9661

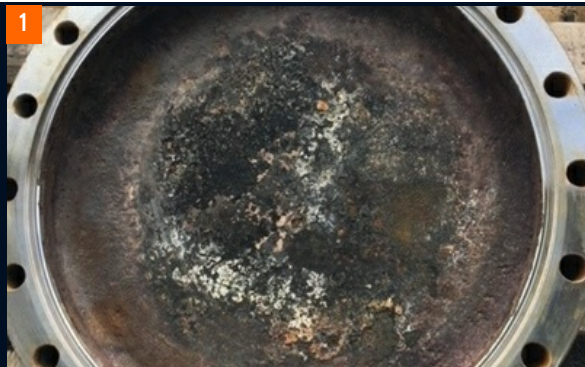
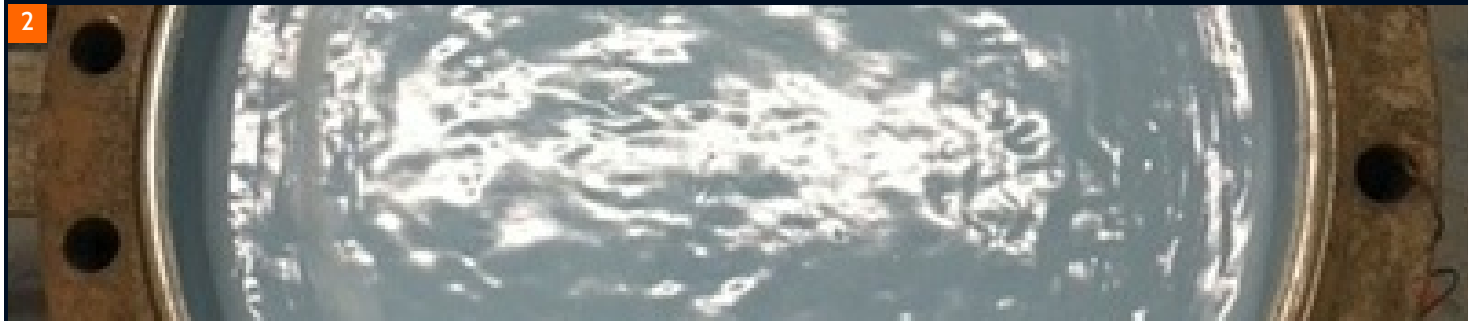
Customer pulled several HEX for routine inspections and discovered bad pitting on one the Cooling Water Heads. They were in a small Pit-Stop and had 3 days to get this repaired and back in service.

1. Cooling Water Head Before
2. Cooling Water Head After

We blasted and filled pitting with 1111, coated with 2 coats of 1391T.
