# PIPE BRIDGE SUPPORT REPAIRS

ID: 9663

## PROBLEM

Several pipe supports had corroded and no longer provided support for the pipeline running across this bridge section.

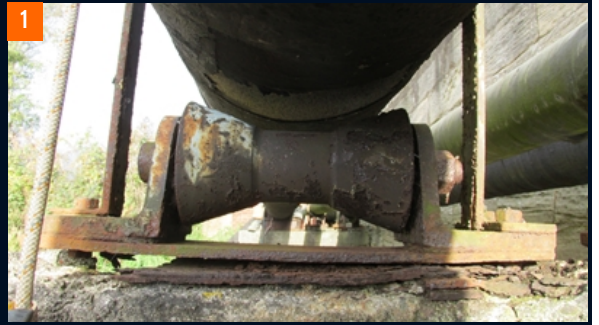
1. Corroded pipe support
2. Area prepared
3. Completed section
4. Larger support repaired using shutter & pour method
