# BELZONA 3131 LONG TERM ROOF PROTECTION

ID: 9664

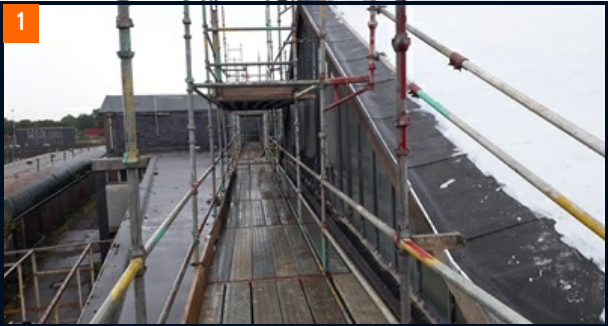
- 1. Belzona 3131 application
- 2. Application underway
- 3. Roof section after 4 years service
- 4. Still in excellent condition

The roofs were first power washed, treated with fungicide. Two coats of Belzona 3131 WG Membrane were then applied.
