# SEWAGE PLANT LEAKING PIPE

ID: 9665

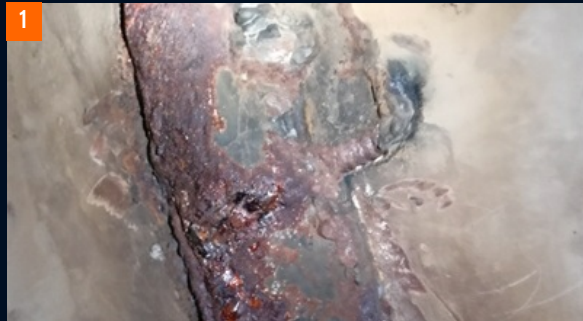
The inner material of the pipe has degraded because wastewater is corrosive. They attempted to stop the leak caused by the metal loss by conventionally welding a metal plate. Because the water could find openings to escape, this approach didn't work.

1. Initial pipe condition illustrating the bonding of the metal pipe with traditional welding.
2. Surface prepared with mechanical tools.
3. Application of Belzona 1161
4. Final repair encapsulated with Belzona 5892
